Degradation, Pollution and Decay of Harem Baths in Topkapı Palace

Assist.Prof. Dr. Fatma SEDES

Istanbul Aydin University -Head of Architectural Restoration Department.

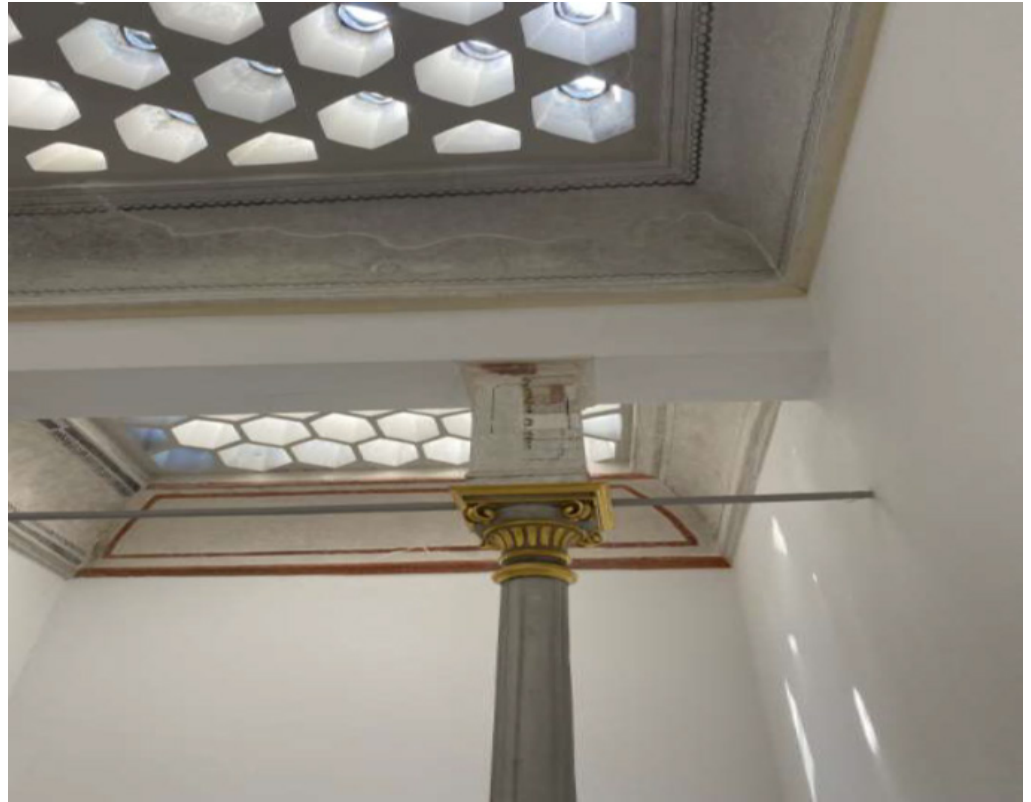
Figure 1

It is known that the Valide Sultan Bath was built in the 18'th century. The Valide Sultan Hamam is located next to the Hünkâr Hamam. The bath consists three parts. Its parts are coldness, warmth and tepidness. It has a small volume compared to the Hünkâr hamam. There is a cold room on the right side of the entrance, and the place is illuminated by bottle windows called elephant eyes (Fig 1).

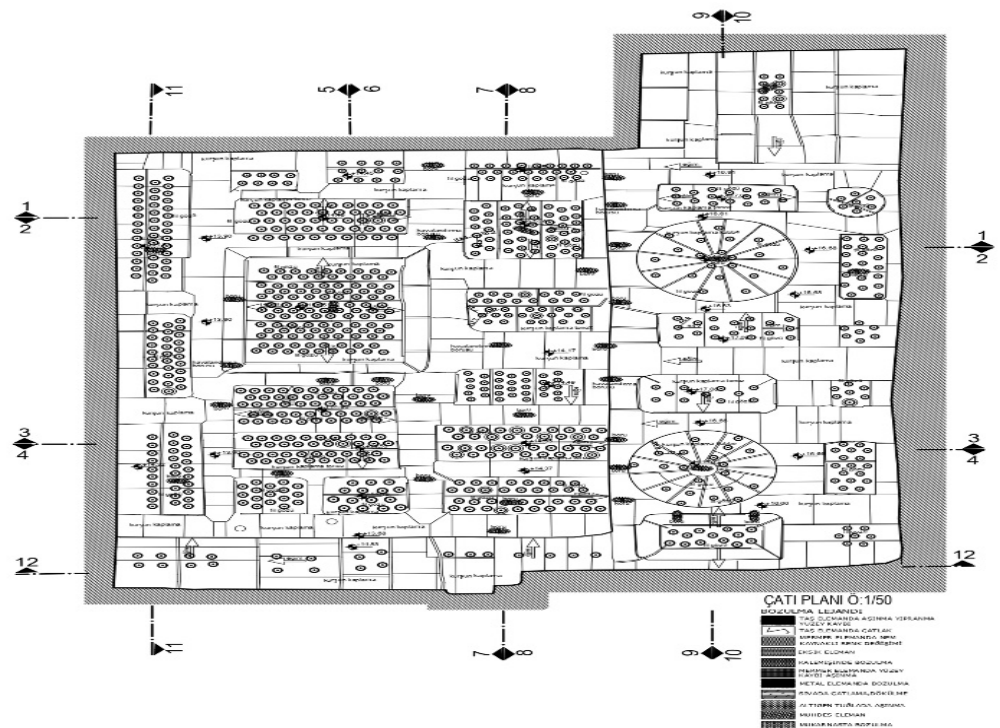
Figure 2

The Hünkâr Hamam (Fig.2) was restored in 1990 with the sponsorship of the a company, and its ornamented and metallic surfaces were gilded. Passing through the Sultan's corridor to the next room, one encounters a marble door – a landing and a second marble door. The first thing to notice on the entrance surface of the marble door is the greasy dirt stains and traces caused by rubbing hands and friction. It is seen that there are cracks in the marble on both sides of the door jamb and bonding was done on the left jamb crack. In the pediment section of the door, iron nails are standing there in an oxidized form, at the level of the column capitals on the right and left. There has been some bleeding in the yellow primer paint under the leaves on the decoration surfaces. In addition, the door has dirty stripes that have swelled in the form of a thin film layer, especially

on the pediment, and there are light dirt accumulations on the edges.

In the lower right and left corners of the door landing, there are parts breakage, dirt accumulations that are thought to be irreversible due to years of use. When one passes the landing and enters the room, can see greasy dirt stains on the inner surface of the marble door caused by friction and contact, traces of metal nails in the upper two corners of the door, and the junction points of the marble blocks, which are not monolithic but cut on the door jambs.

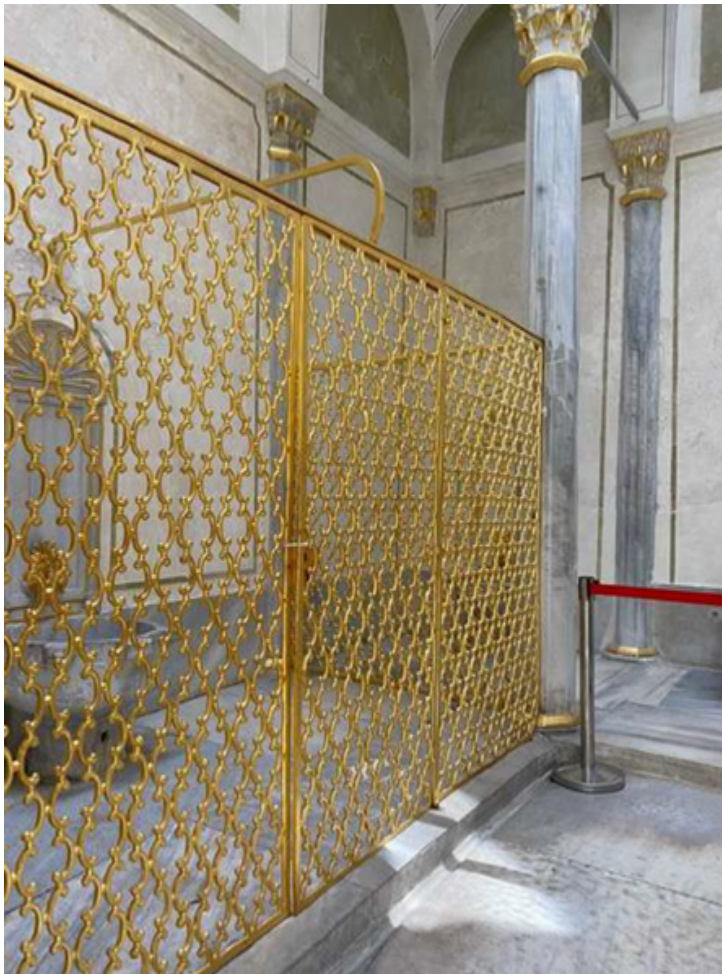
Figure 3

The floor, which comes out of a threshold, is covered with marble and the marbles consist of blocks of different sizes. The wall surfaces are also covered with marble blocks up to half a meter high. Intense rust stains on the floor marbles (probably the blocks were connected from the bottom with

iron clamps or lead clamps and oxidized due to water and moisture leaking over time and this oxide layer was absorbed by the marble and spread to the surfaces), abrasions caused by use on the surface, small cavities in places. There are dirt accumulations, joint discharges, and linear surface losses at a depth of about half a millimeter in the marble on the side wall surfaces. This place, which has three niches on the right and left of the entrance (Fig.3), also has wear and oily dirt accumulations caused by use on the seats in the niches. On one of the wall surfaces of the room, there are two pieces of old wall remains, the surface of which has been scraped in separate pieces and the hand-drawn decorations have come out of the lower surface. Reinforcement was made using Portland cement on one side of the larger piece. Also, on plastered wall surfaces (there is the same application throughout the bath).

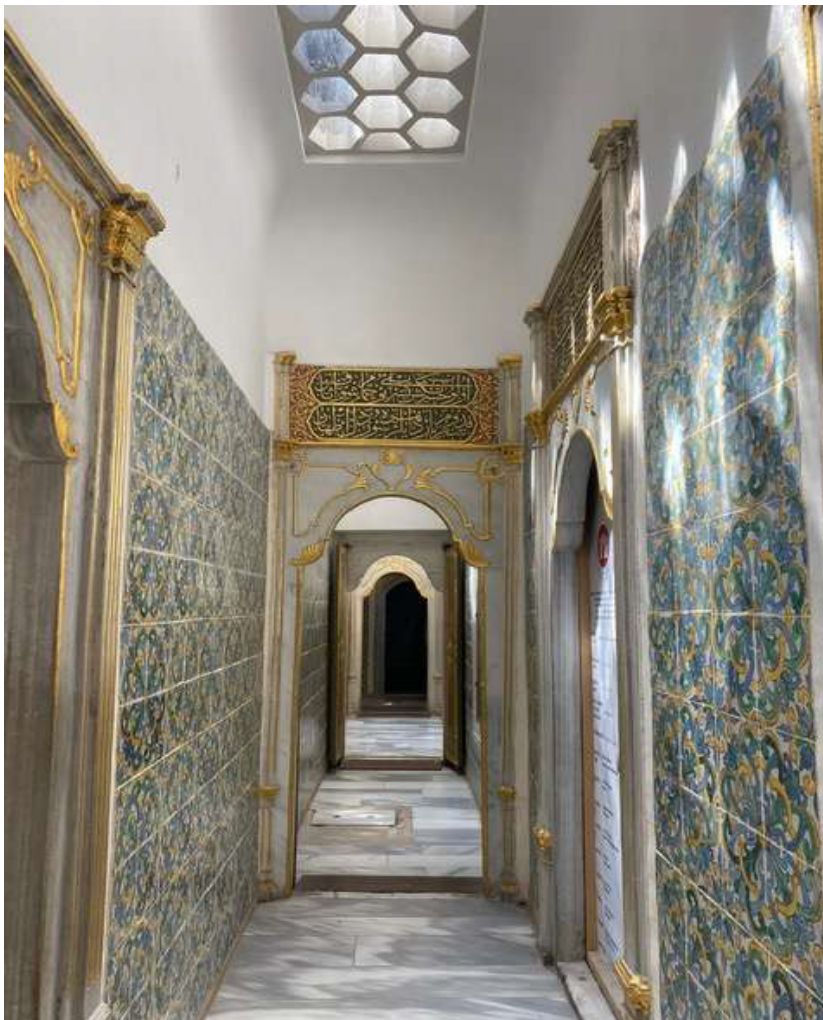
Figure 4

The application was made using cement-bonded plaster. Due to moisture and leaking water on the plastered wall surfaces (soluble salts crystallized under the paint layer and the paint swelled), there are swellings and spills in the paints. In addition, there were occasional thin cracks on the wall surface, and more pronounced cracks in the form of curves, running parallel to each other, on the lower surface of the beam. These cracks are deeper in some places. There are remnants of old pencilwork on the ceiling vault of this unit. The water flowing by finding its way through the lighting glasses of the vault also caused water stains on the side surface of the vault (Fig.4).

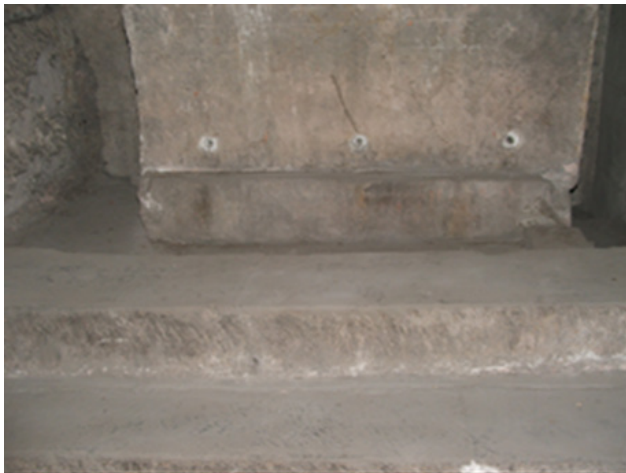
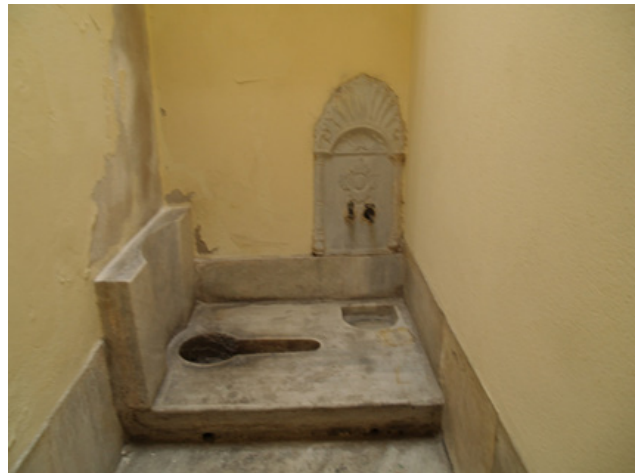
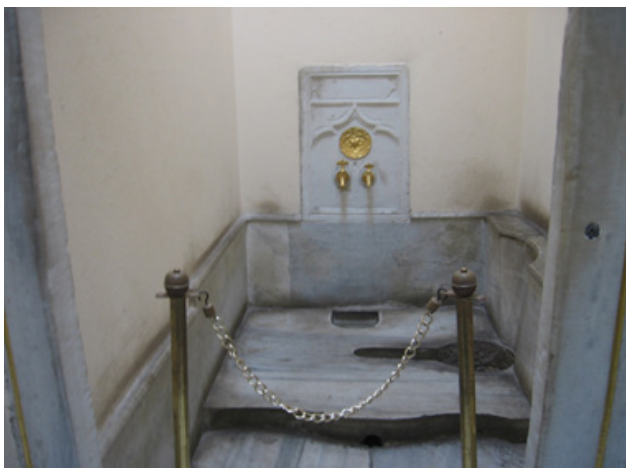
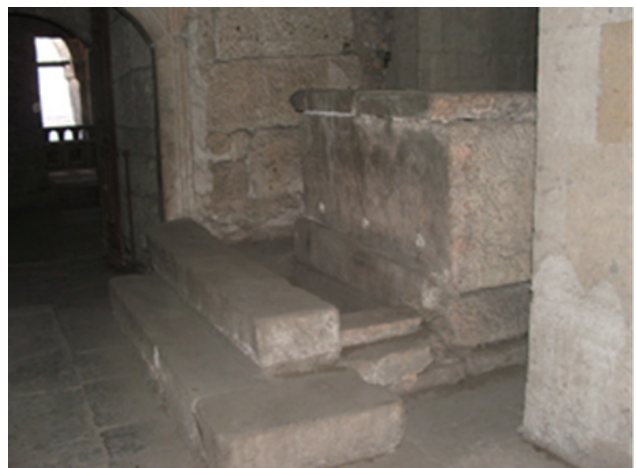
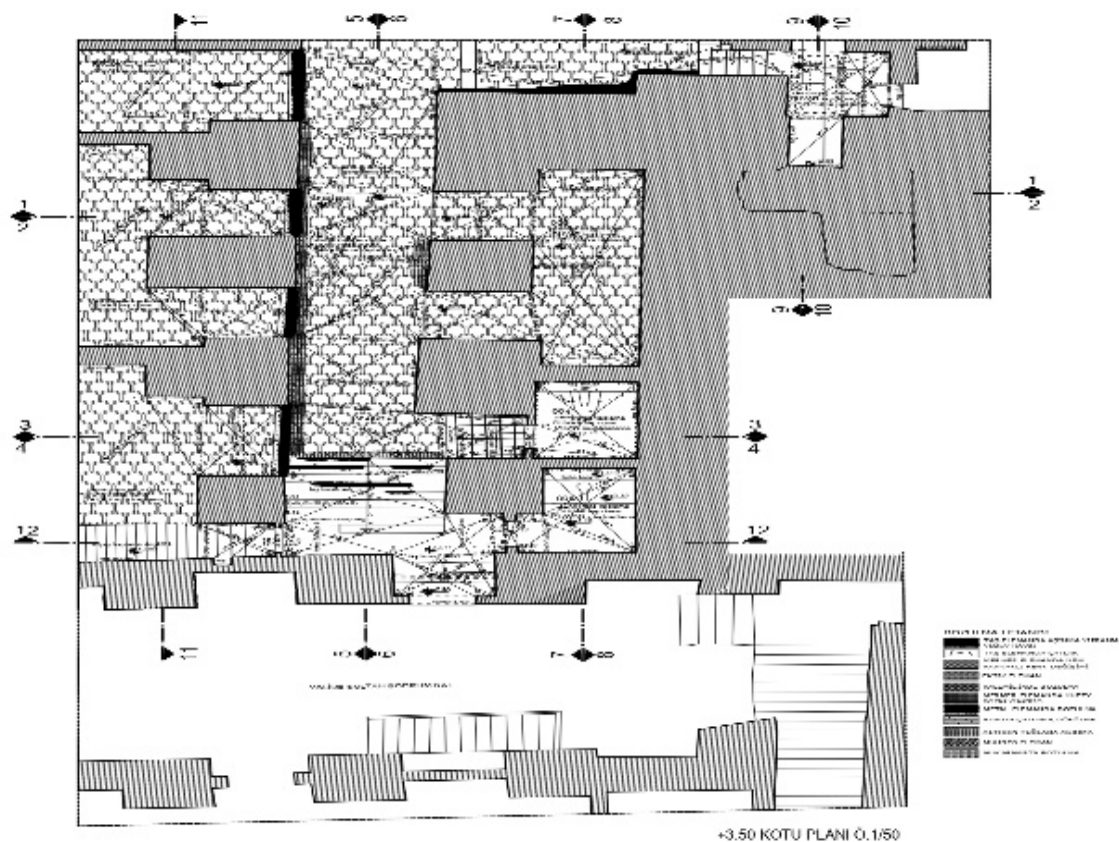
There is a carved area. The faucets have been cleaned, foiled and appear to be in good condition during the last repair (Figs.5,6,7,8,9) There are only traces of stains from the water that has probably already seeped down from the area where the faucets are mounted to the wall. There is a slight accumulation of dirt in the upper left corner of the mirror stone. The traces of oily dirt on the marble block surfaces surrounding the wall inside the room appear more intense, especially at the points in contact with the plastered wall. On

the wall surfaces of the toilet plastered with cement-binding plaster, paint swells, and on the parts near the upper ceiling, paint flaking is more intense, and there are plaster swells in places. There are also stains and paint blisters around the electrical panel on the right side of the entrance of this place. There are gilded linear contours on the outer surface of the marble door jambs at the entrance of the toilet, and there are traces of oily dirt caused by friction and touching.

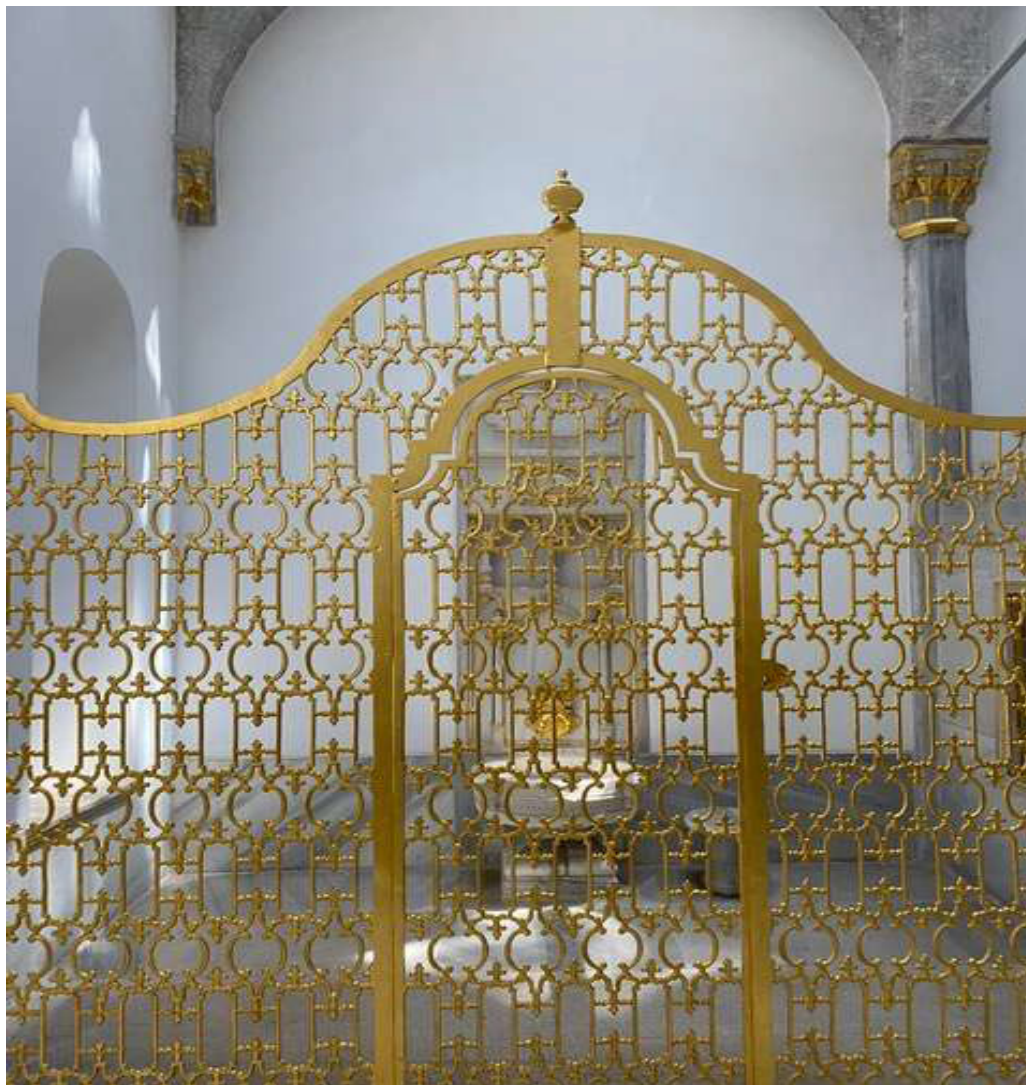
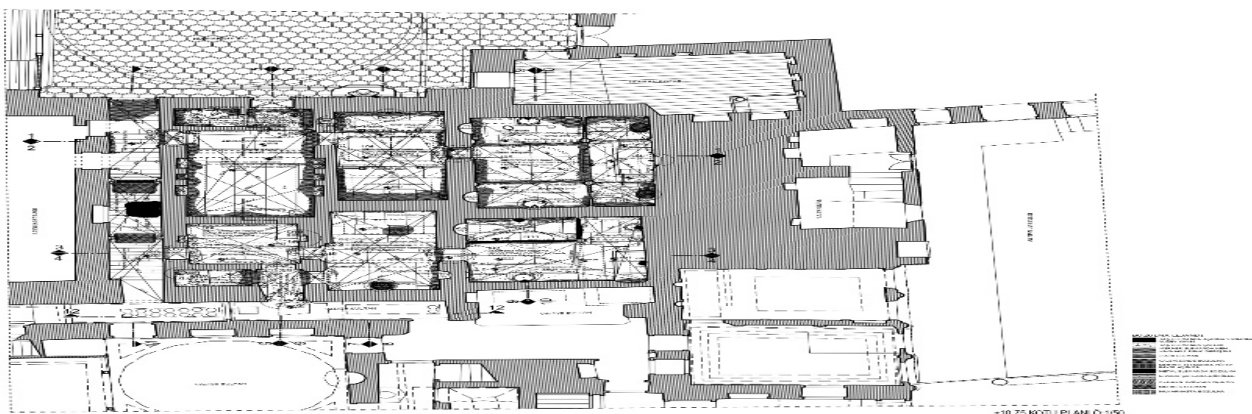
The surface of the decorations on the front surface of the entrance to the room the façade facing the next room is covered with gold leaf. On the left side of the door, there is a part of the hinge at the bottom (Fig.11, 12).

However, the metal pieces, which were present in two separate places in the upper part, oxidized and caused cracks in the jamb (there is a transverse and longitudinal split) and rust stains. On the right jam. There are traces of dirt caused by friction and touching throughout the door. There are small part breaks on the outer edge contours of the door jamb. On the door surface facing the mentioned room, there are dirt accumulation due to crawling and touching, crack formation in the upper right parts of the jamb, very small breaks in the outer contour. The hinges on this door are on the right side and are still in place. In addition, there is a metal clamp on the jamb surface, which is interlocking with each other. On the left side of the door jamb, there are metal nails on the inturning part of the jamb and a hinge (hook) near the upper arch. There is a crack in the door sill stone between the two doors. When entering room, a water channel passes in front of the inner threshold. This channel surrounds the base, which is located in the middle and consists of six block pieces. Like here, along this channel, there is an accumulation of dirt embedded in the marble on the marble surfaces.

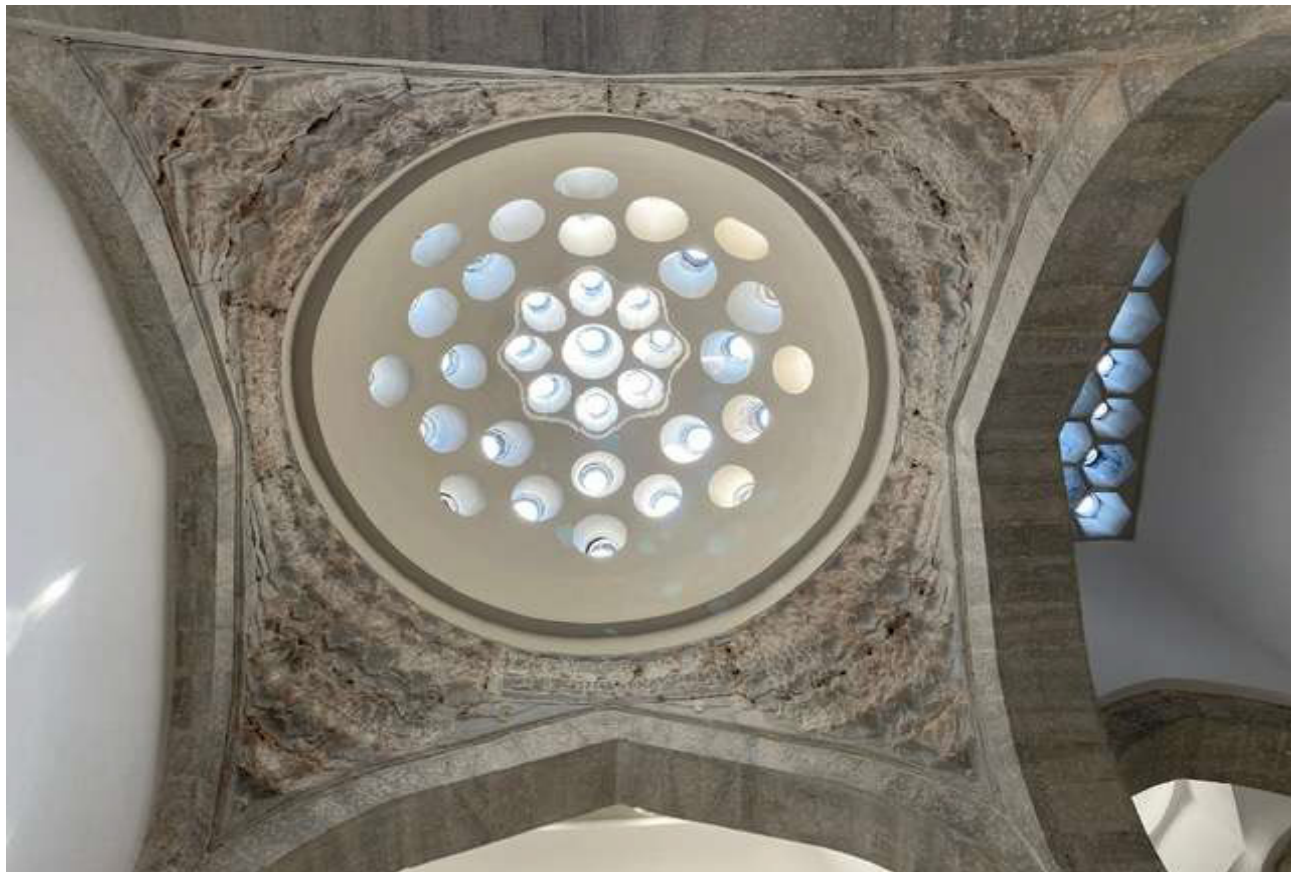
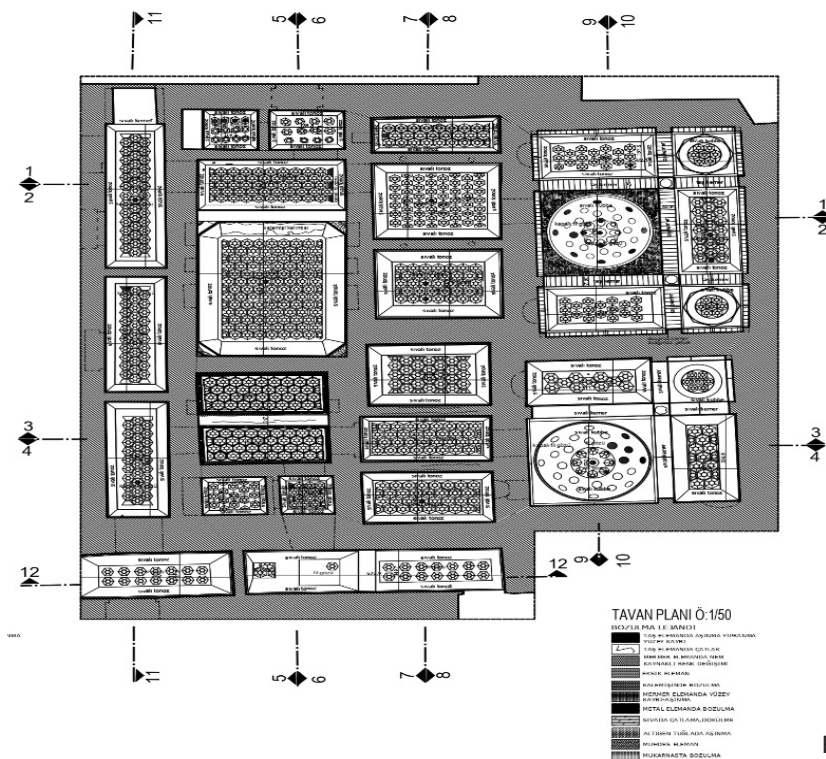
On the surface of the ground blocks, there were abrasions and occasional inward indentations. Again, there are rust stains originating from the sub-surface, although not common. Hairline cracks also occurred in a few blocks. In this place, there is a central dome rising with a column and vault system in the middle (Figs.13,14). There are serious surface losses in the marble muqarnas (it can be understood from a

distance, as well as marble-smash) adorning the corners of the dome.

Between the point where the herringbone decoration ends and the transition point to the seashell decorated turn, cracks have formed in the marble. On the upper part of the faucet standing in the middle, there is a narrow and thin water trough, and small circular cavities opened to prevent the accumulation of water in this trough. The fillings in the lower parts of the small pillars on the right and left sides of this small water trough were poured. The large bathtub is entered by descending the stairs placed inside. On the right and left sides of the tub, there are marble benches decorated with parapets at the front and back and with seats inside. There is also wear and color change on these marble stone

surfaces. There are also joint discharges at the marble parapet junctions surrounding them. Among the gilded faucets found in the mirror stone, the bronze faucet on the far right started to oxidize and the green oxide layer came to the surface of the gold leaf.

Again, on the side of this faucet, both the joint between the tub blocks were emptied and the metallic connection that held the tub stones together disappeared. There are also surface abrasions, crack formations and staining (yellow paint and different paint residues from the outside) as well as slight yellowing on the inside of the tub. Again, on the upper parts of the mirror stone, small pillars were filled with horosani mortar in the corner of the column on the left.

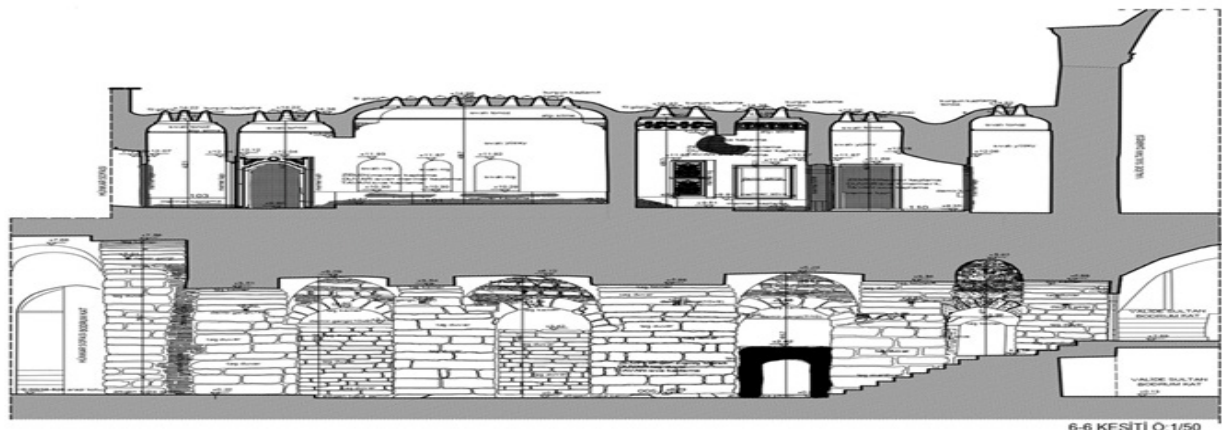
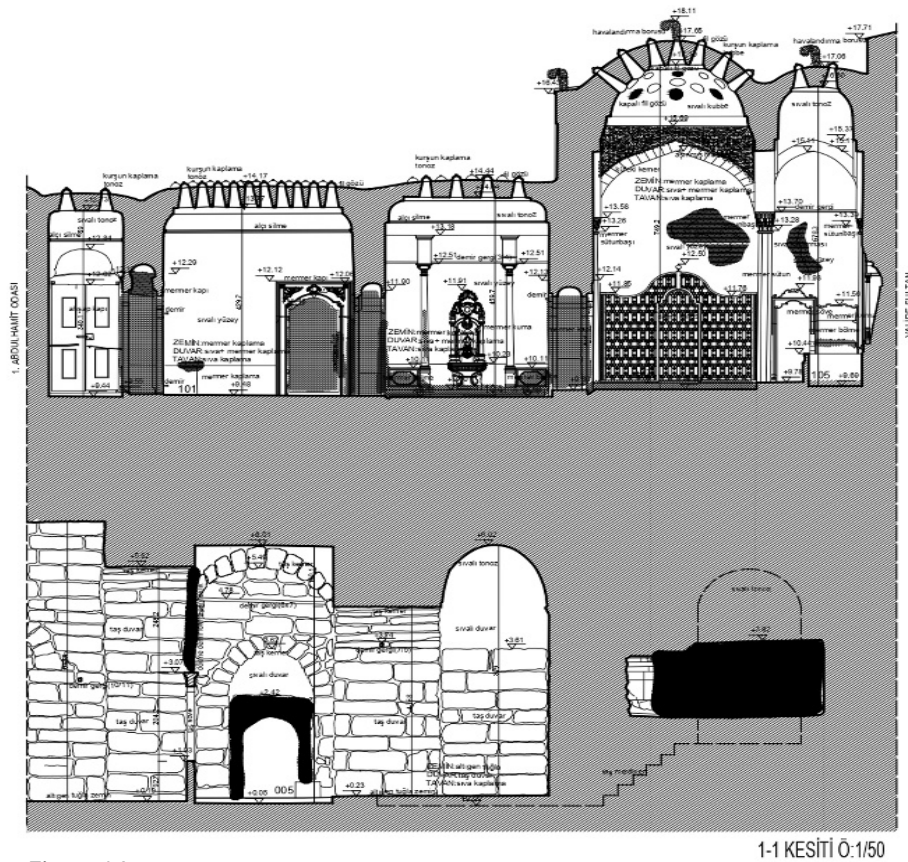
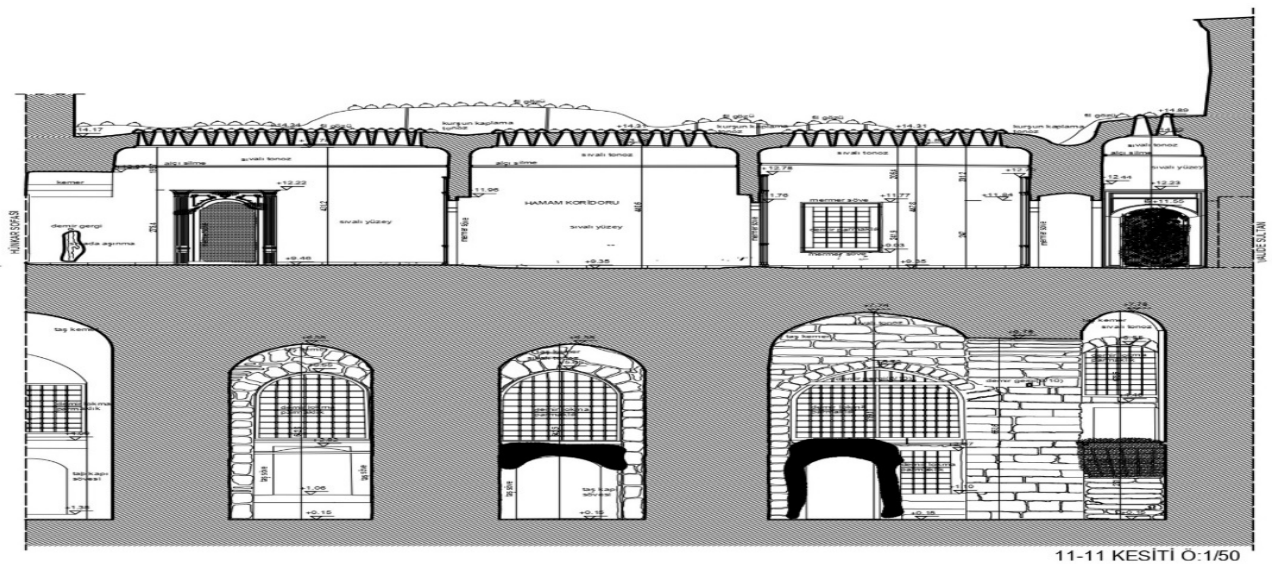
On the right side there is an open front with a fountain with cracks in the floor stones, dirt accumulations and joint gaps at the bottom and a wavy rust staining. In the mirror stone of the fountain of this place, there are two-eyed and flower-patterned tile-covered niches. There have been intense spalling and loss of parts on the surface of the tiles. Existing ones also have crack formations. The mirror stone of the fountain is generally in good condition. There are traces carved for hooks only on the right and left upper parts of the gilded faucet. Color change and slight wear are seen on the inner surface of the basin due to use.

There is joint discharge. There is a niche at the bottom right of this unit, as in the opposite unit. There is a slight color change on the sitting stone of the niche (figs.15,16,17).
