Article

Topkapi Palace Harem Hospital

Fatma SEDES (Dr. Öğr. Üyesi)

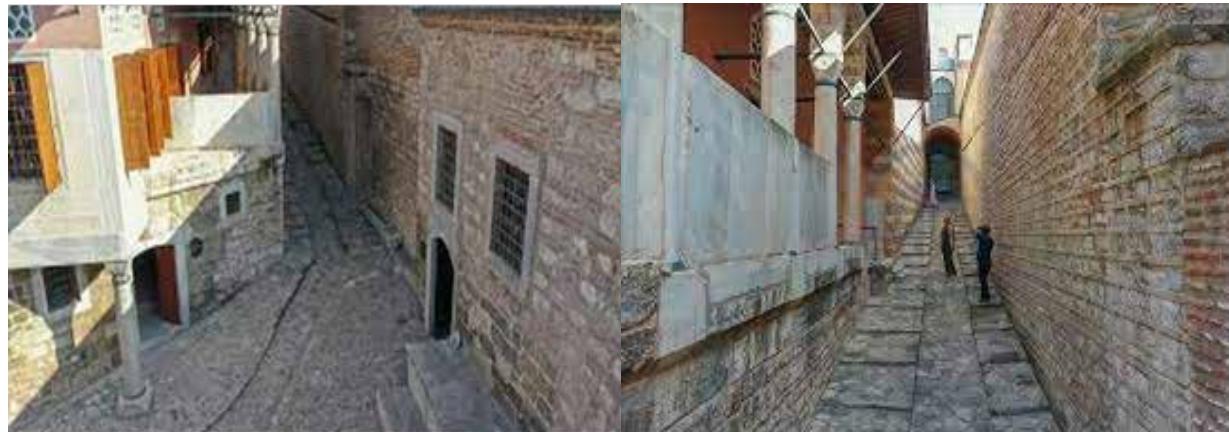
(Fig.2-3) Palace Great Boarding - Shawl Gate (www.aa.com.tr)

wash room across the stone. Those who died in the harem were washed here and taken out from the dead gate at the back.(Fig.1-2-3)
